Flood stories, written in river — Photos by Christine Hatch

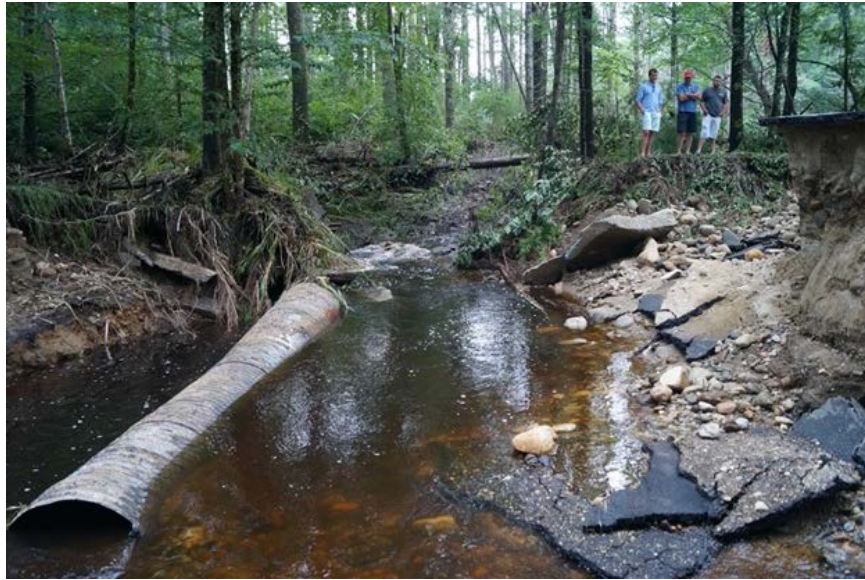
Half of a severed and washed-out 3-foot-wide culvert at East Street in Belchertown. Debris carried by intense rains overtopped the beaver dam (still standing, at road level, rear) and clogged the undersized structure, causing the road failure and flooding. Flow is top to bottom.

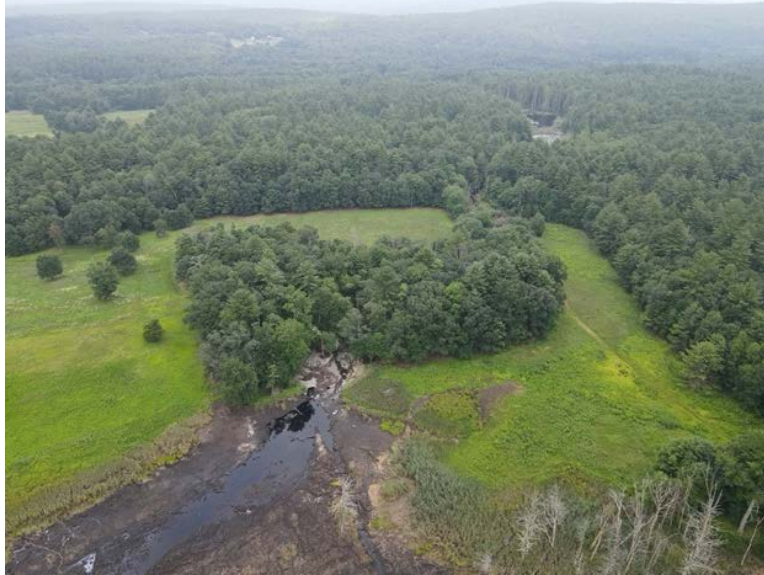
On July 17, intense rains after several wet weeks overwhelmed a 70-year-old beaver dam in Herman Covey Wildlife Management Area in Belchertown (foreground). Floodwaters rushed into a second beaver pond (upper right), where the flood wave was largely captured and attenuated. Flow is bottom left to top right.

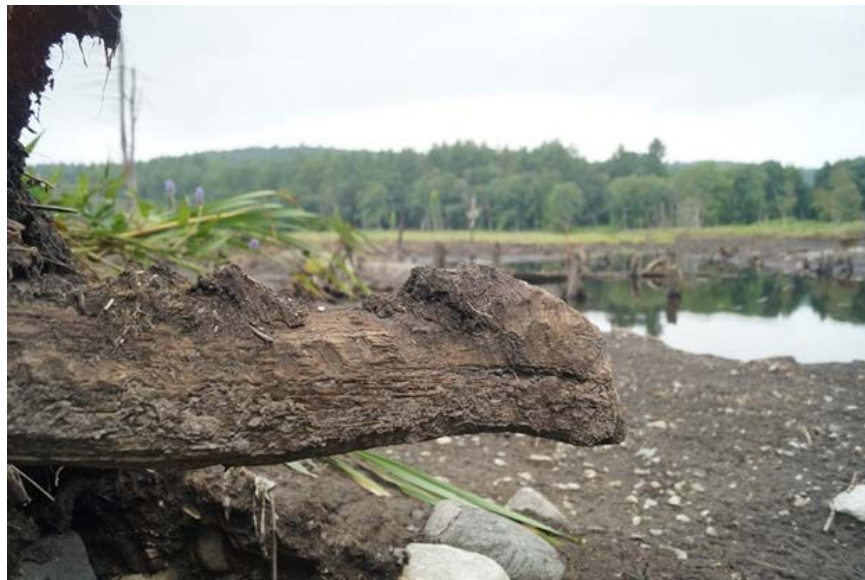
Chewed wood marks the former location of a 70-year-old beaver dam in Herman Covey Wildlife Management Area in Belchertown which failed and drained suddenly on July 17, after intense rains. Behind the upstream dam, a vibrant wetland thrives, storing carbon and organic material, filtering water, and capturing stormwater — until now.

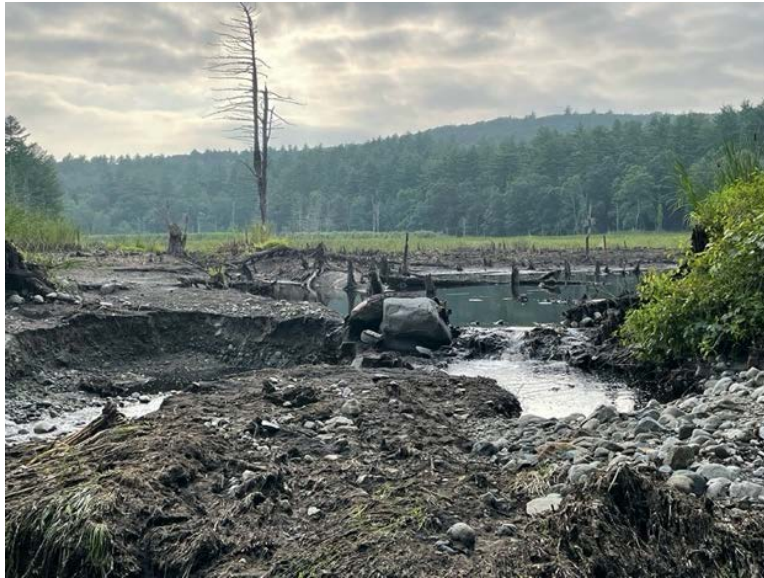
The sudden failure of a beaver dam in Herman Covey Wildlife Management Area produced a powerful flood that carved deep into underlying glacial till, and carried down rich organic material that had accumulated for over 50-70 years to the floodplain below where it was deposited. Flow is from top right to bottom left.

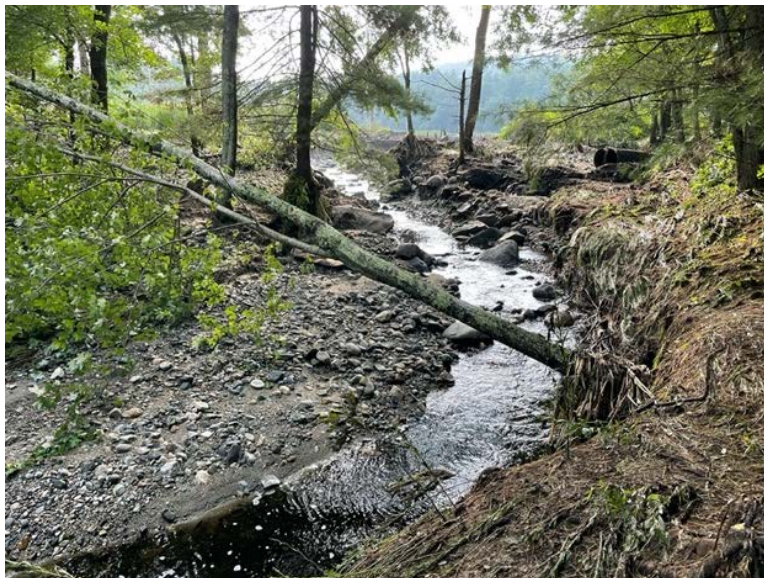
As a powerful flood wave from a failed beaver dam ripped through this small tributary, banks eroded and new wood habitat was drawn into the waters. Dark, tannin-rich water drains from the pond sediments, newly exposed to oxygen after the flood. Flow is from top to bottom.

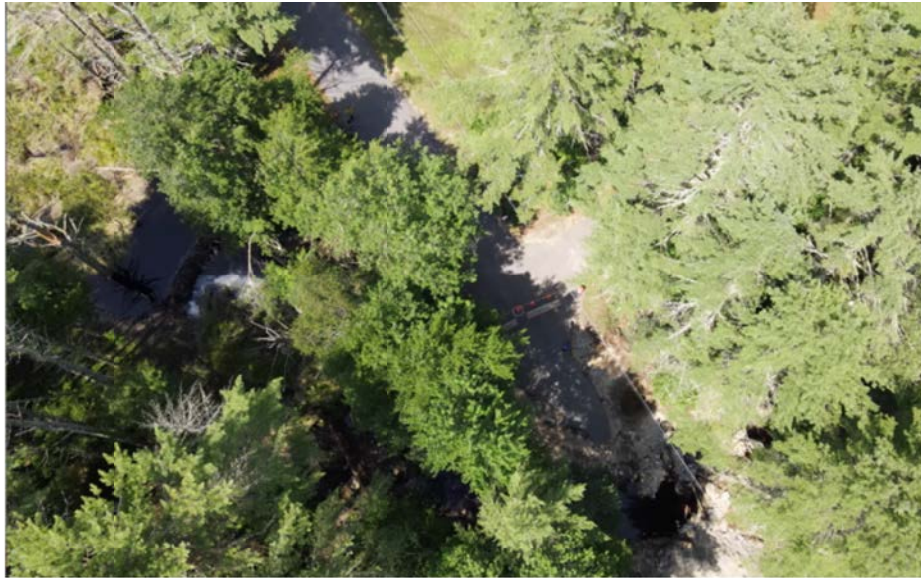
Six days after the road collapse at East Street in Belchertown, nature's engineers are shoring up their structures (top left) behind the pile of debris that was carried up and over their dam (still intact) during intense rains. Debris clogged the undersized culvert at the road, raising water levels to about 2 feet above the road (and top of the beaver dam), ultimately eroding the roadbed, causing catastrophic failure, and significant downstream flooding and damage to homes. Flow is from left to right.
